THE CALIFORNIA EARTHQUAKE OF APRIL 18, 1906

STATE EARTHQUAKE INVESTIGATION COMMISSION

IN TWO VOLUMES AND ATLAS

ANDREW C. LAWSON, CHAIRMAN

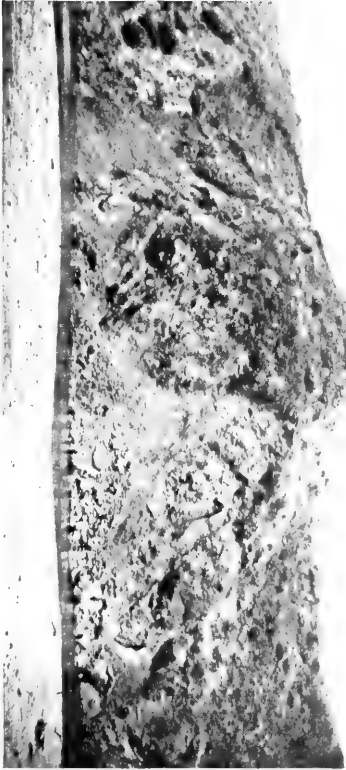
A. Rocky stream cliff 50 feet high on north side of Alder Creek. Fault vertical on left of knoll; auxiliary fault on right of knoll. F. E. M.

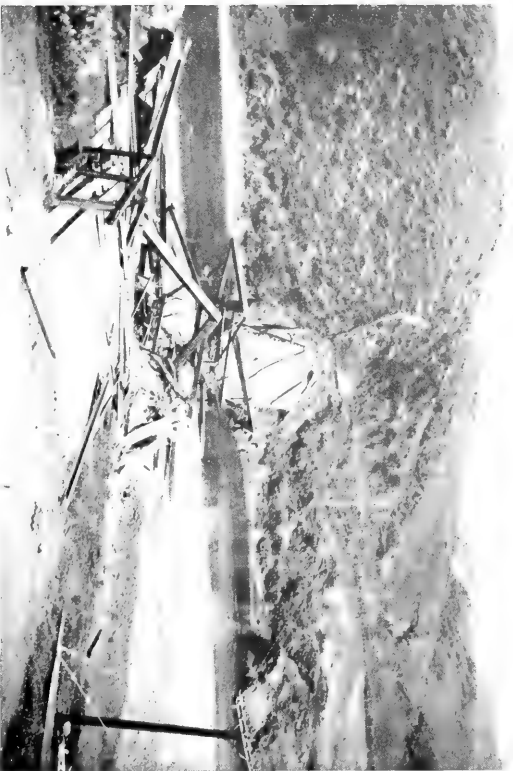
Southeast of this point, the fault-trace follows the broad stream bed of Alder Creek for nearly a mile, passing beneath a bridge, the wreck of which is shown in plate 32B. In this view, the horizontal offset of the bridge along the fault-line is well shown. It is apparent that this offset is not less than the width of the bridge. On the southwest side of the stream, near the bridge (A, fig. 12), the fault-trace is flanked by peculiar, isolated, rocky knobs similar to that on the northeast side. It is not clear, however, that these rocky knobs have more than an accidental relation to the fault, since they may possibly be residual sea-stacks upon the uplifted wave-cut terrace.

B. Fault passing under bridge over Alder Creek. Bridge displaced not less than its width. F. E. M.

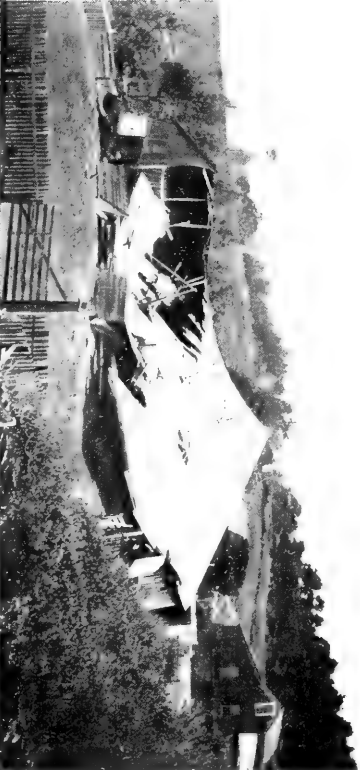
C. Barn of E. E. Fitch, north of Manchester. Astride the fault. F. E. M.

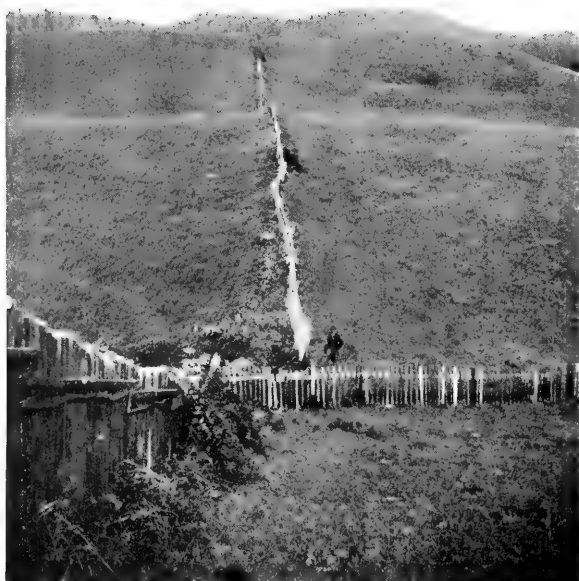
A. East-west fence near saddle between Garcia River and Brush Creek. Main offset 13 feet. Auxiliary offset 2.5 feet in middle ground. F. E. M.

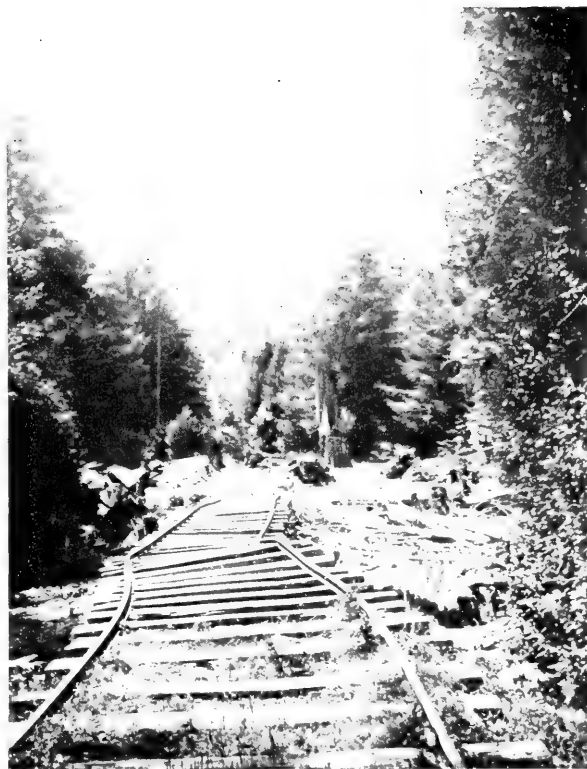
B. Small railway trestle, Little North Fork Gualala River, looking north. Main fault-trace 100 feet to right. Auxiliary crack under trestle. F. E. M.

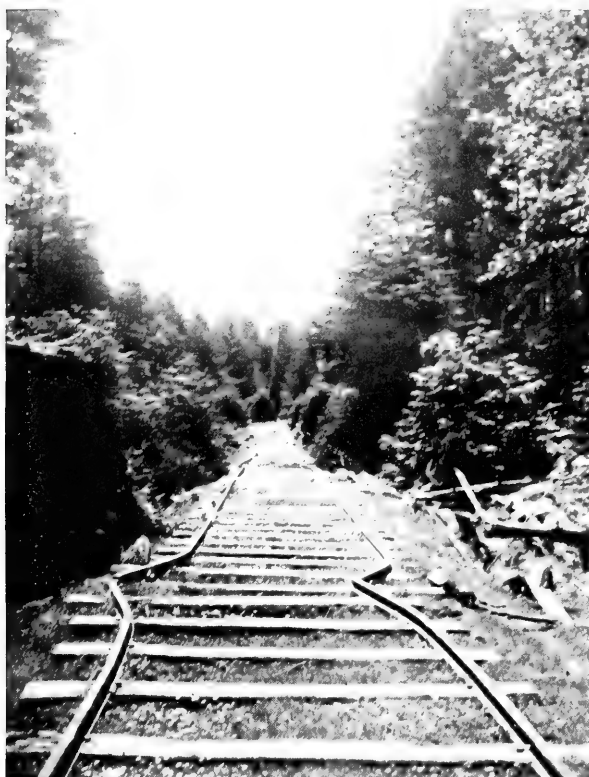
Down the Little North Fork, the fault-trace follows the axis of the valley on its west side; at a point 1.5 miles north of its junction with the North Fork it runs lengthwise for over 100 yards with the grade of an abandoned logging railroad, tearing the same to pieces. Interesting evidence of the condensation or shortening of the ground in this vicinity is afforded by the buckling of the rails as seen in plate 33b. Here the main line of dislocation lies about 100 feet to the east of the track in the stream bed. The effect of the movement was to shorten the steel rails either by buckling or telescoping after the snapping off of the fish plates. The small trestle in the distance is traversed at an acute angle by an auxiliary line of dislocation and is similarly shortened. At the locality shown in plate 33c, the buckling in the foreground resulted in the breaking of the rails. Similar instances of the shortening of the steel are shown in the distance. Here the main line of dislocation of the earth lies about 50 feet to the east of the track, and parallel with it. Plate 33b is a nearer view of the trestle above referred to. Below this point the fault-trace lies in the stream bed for some distance, crossing the North Fork at a point 200 feet east of its junction with the Little North Fork. Two lines of faulting appear here, both of which caused considerable damage to the railroad track; but the latter having been repaired before the date of Mr. Matthes' visit, no measurements of offsets were obtainable.

C. Buckled track, Little North Fork Gualala River. Both rails broken. Fault-trace parallels track 50 feet to left. F. E. M.

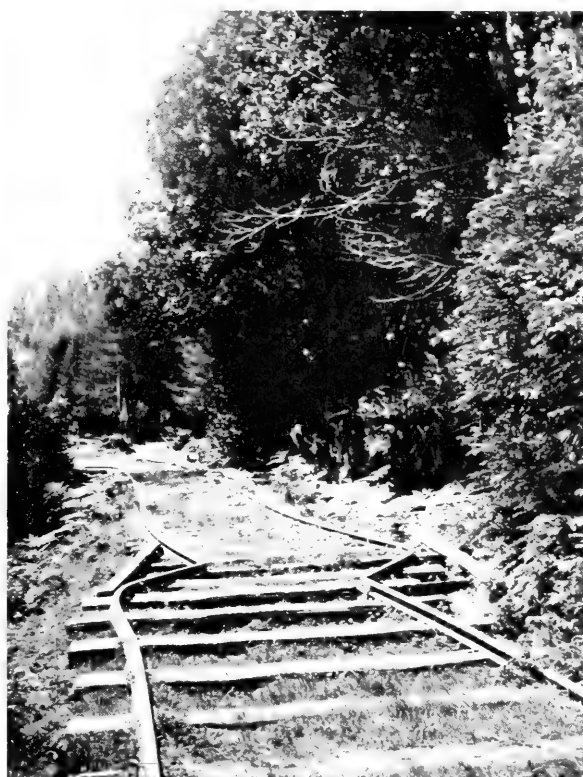
D. Buckled track, Little North Fork Gualala River. Fault-trace 100 feet to left. F. E. M.

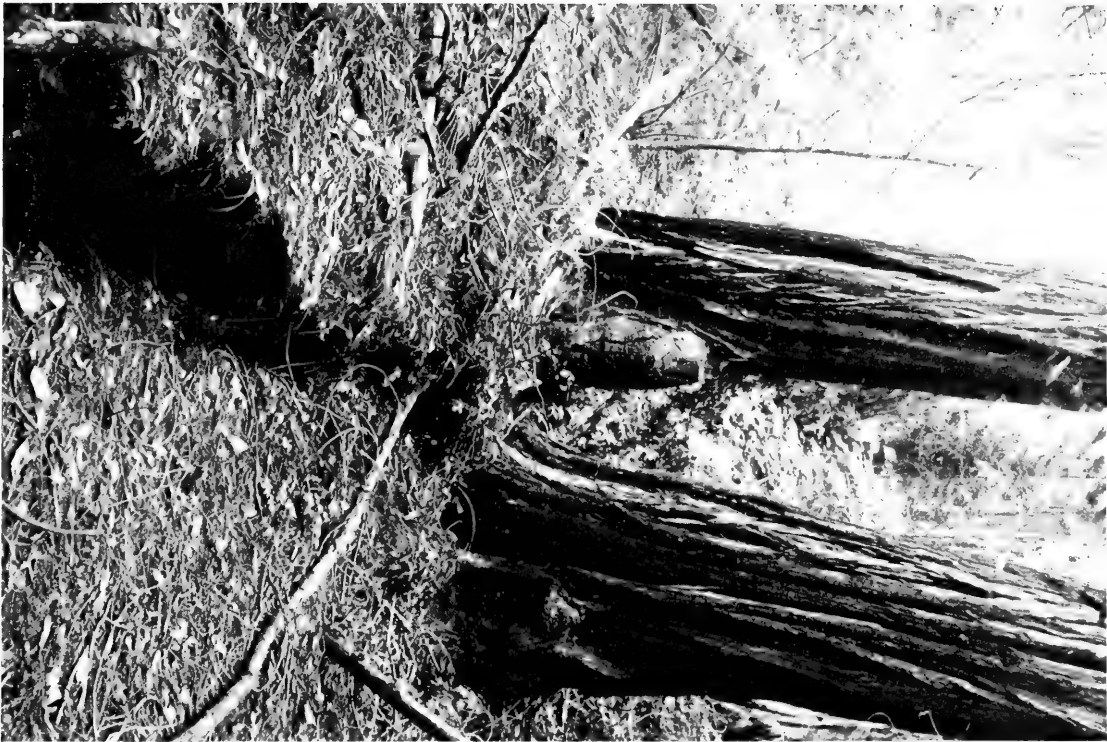
A. Fault-trace in redwood forest near Fort Ross, J.N.L.

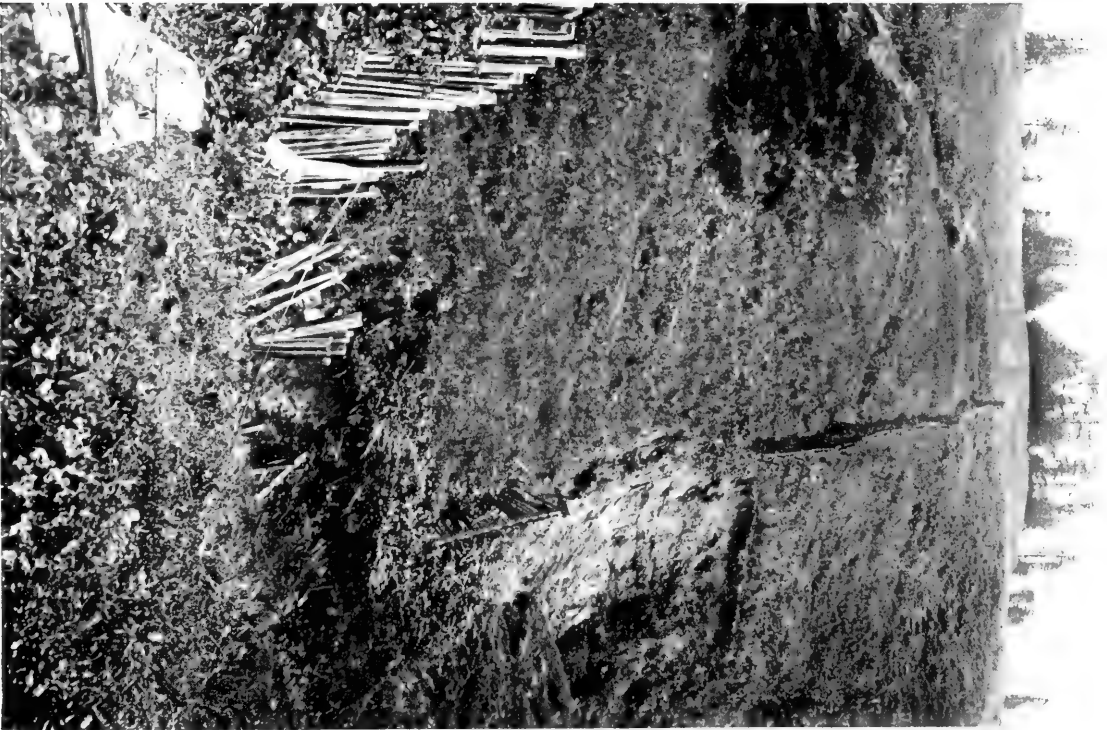
B. Dislocation of fence near Fort Ross, J.N.L.

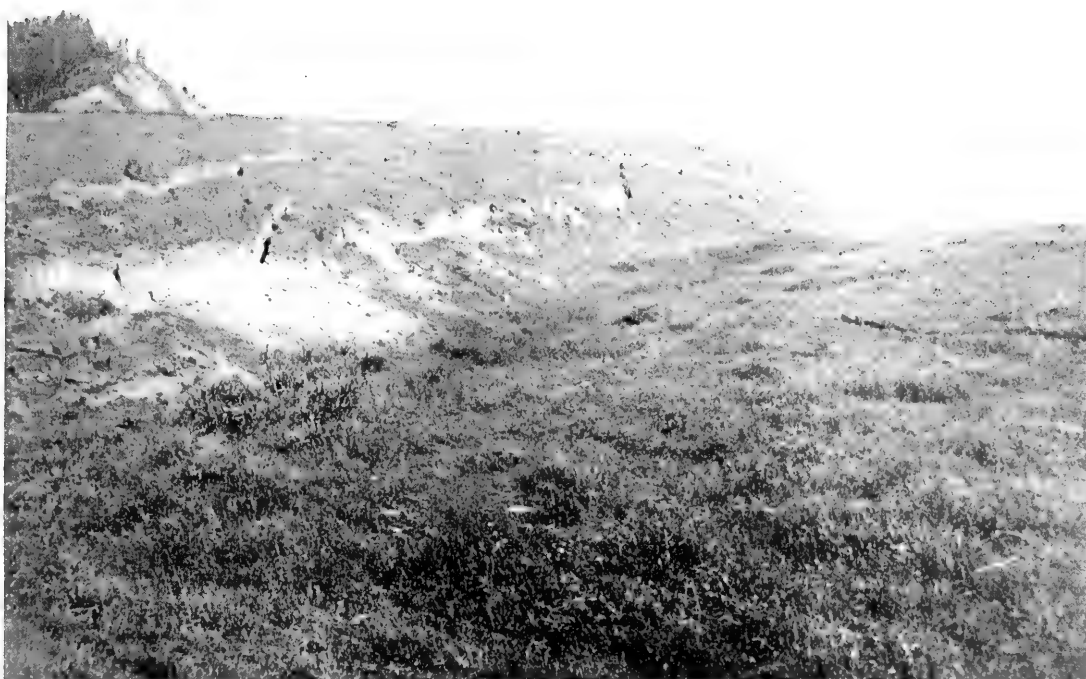
A. Accentuation of old scarp by new fault 1.5 miles north of Fort Ross. J. N. L.

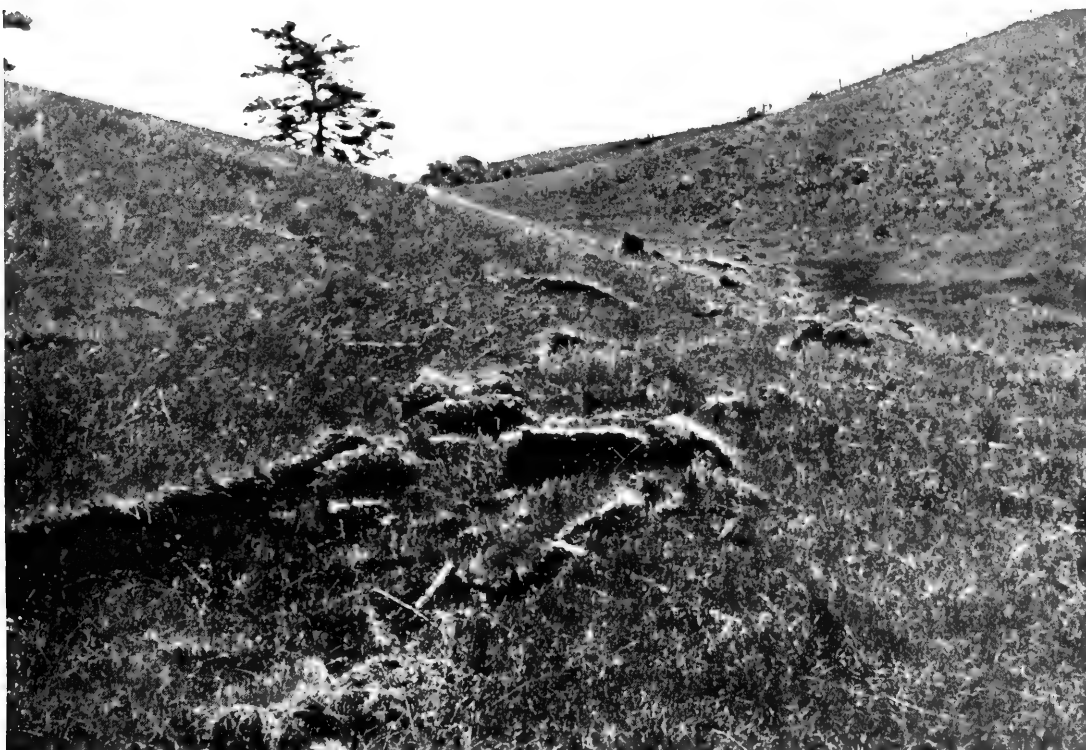
B. Fault-trace on grass-covered slope near Fort Ross. R. L. H.

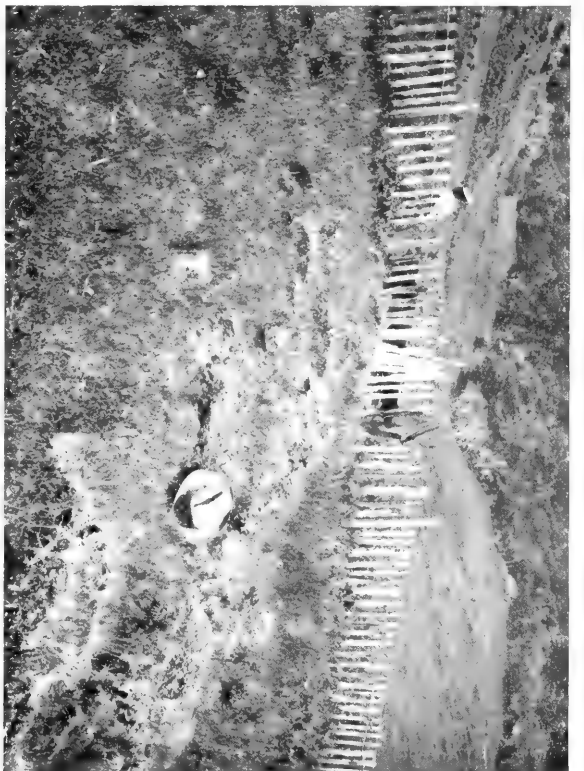
B. Fault-trace and dislocated fence near Fort Ross, R. S. H.

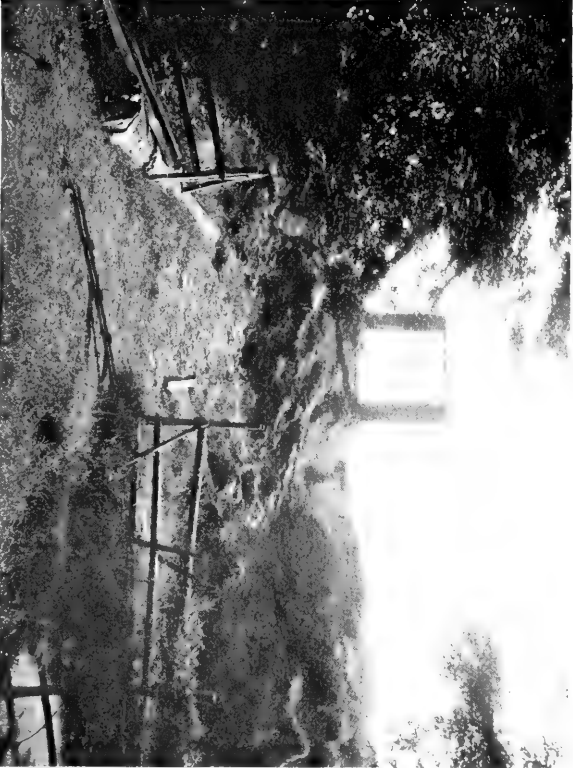
C. Roadway offset 12 feet. New fault-scarp 3 feet high, facing northeast. Above Fort Ross, F. E. M.

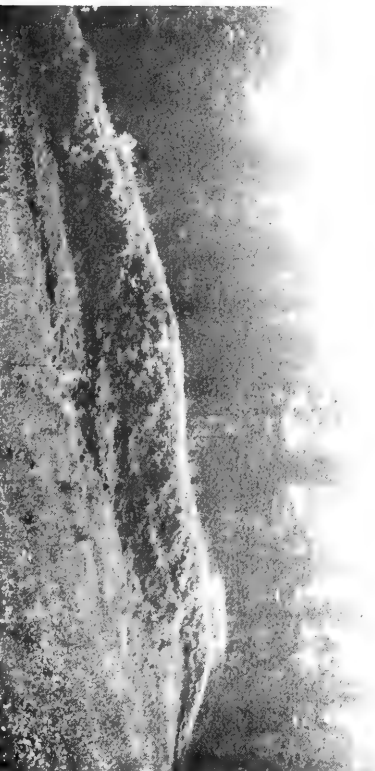
D. Accentuation of old fault-scarp by new fault. Near Fort Ross, F. E. M.

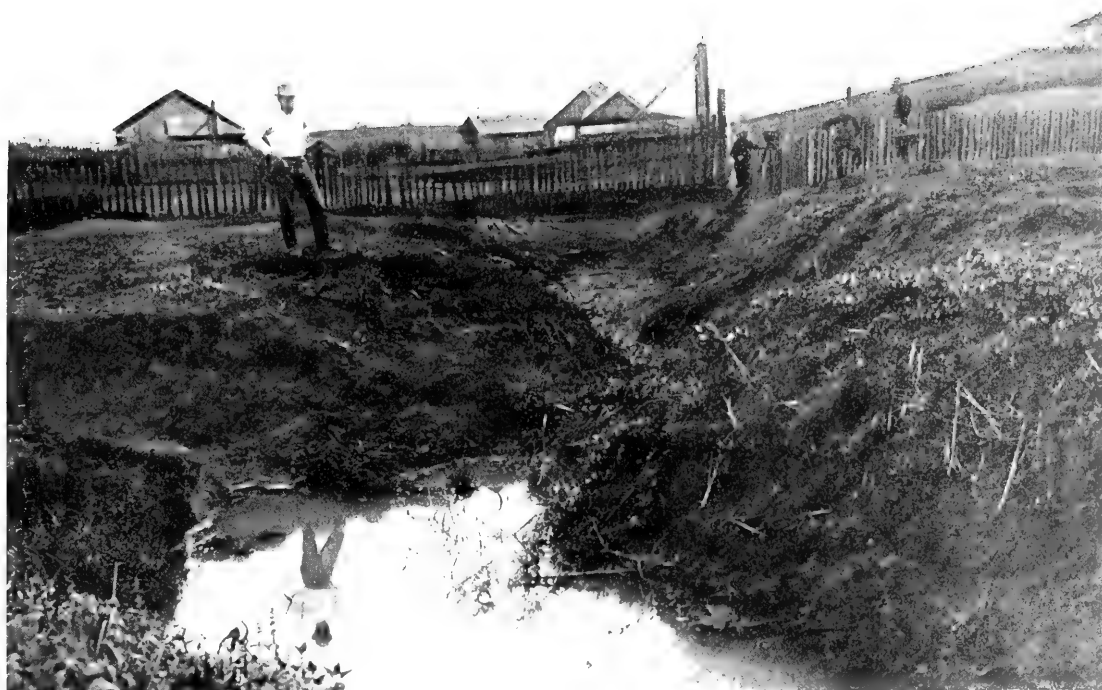
A. Offset of stream trench by the fault and ponding of water by the fault-scarp. Doda's ranch, a mile southeast of Fort Ross. A. C. L.

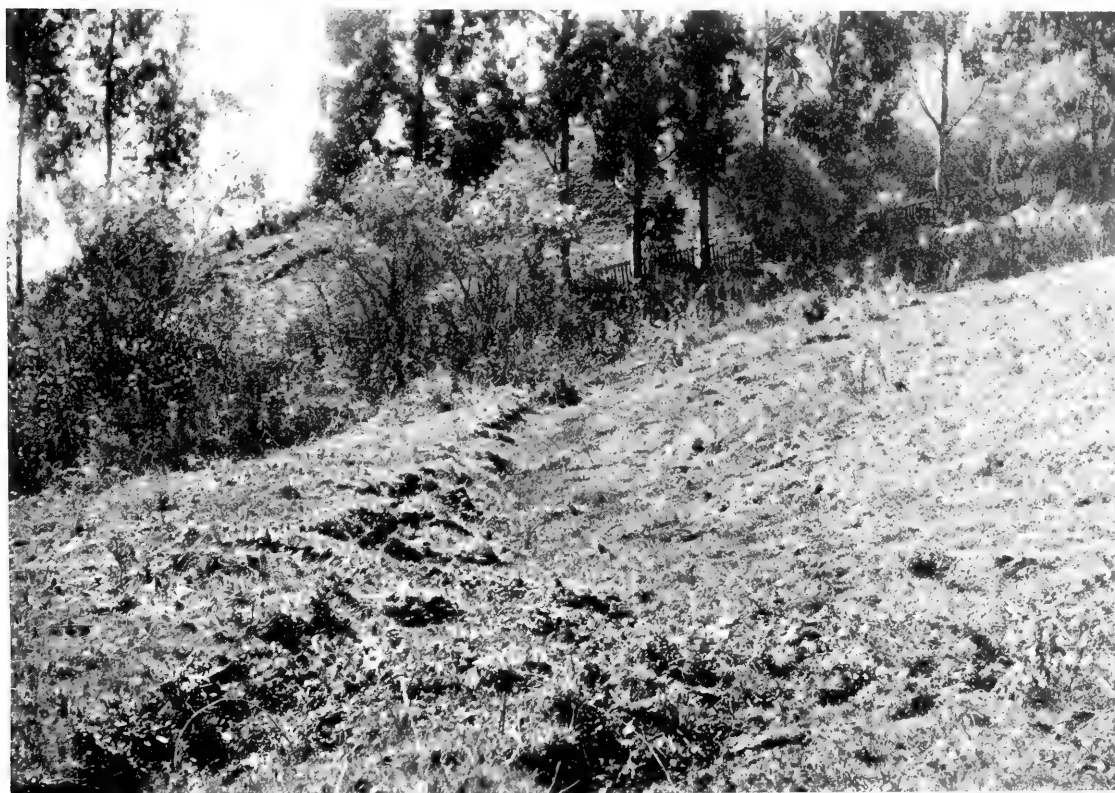
B. The fault-trace a mile northwest of Bolinas Lagoon, looking southwest. Illustrates the ridge phase. G. K. G.

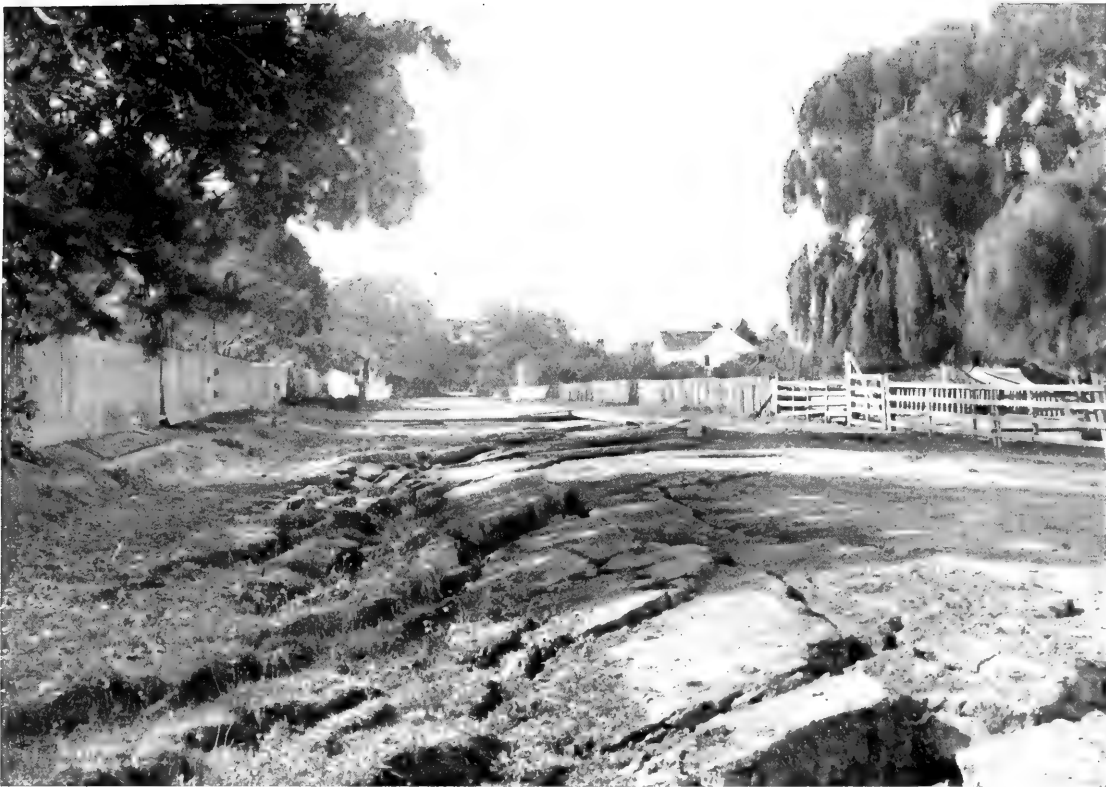
A. Branch of fault-trace in north part of Bolinas. Looking north-northwest. Illustrates diagonal cracks. G. K. G.

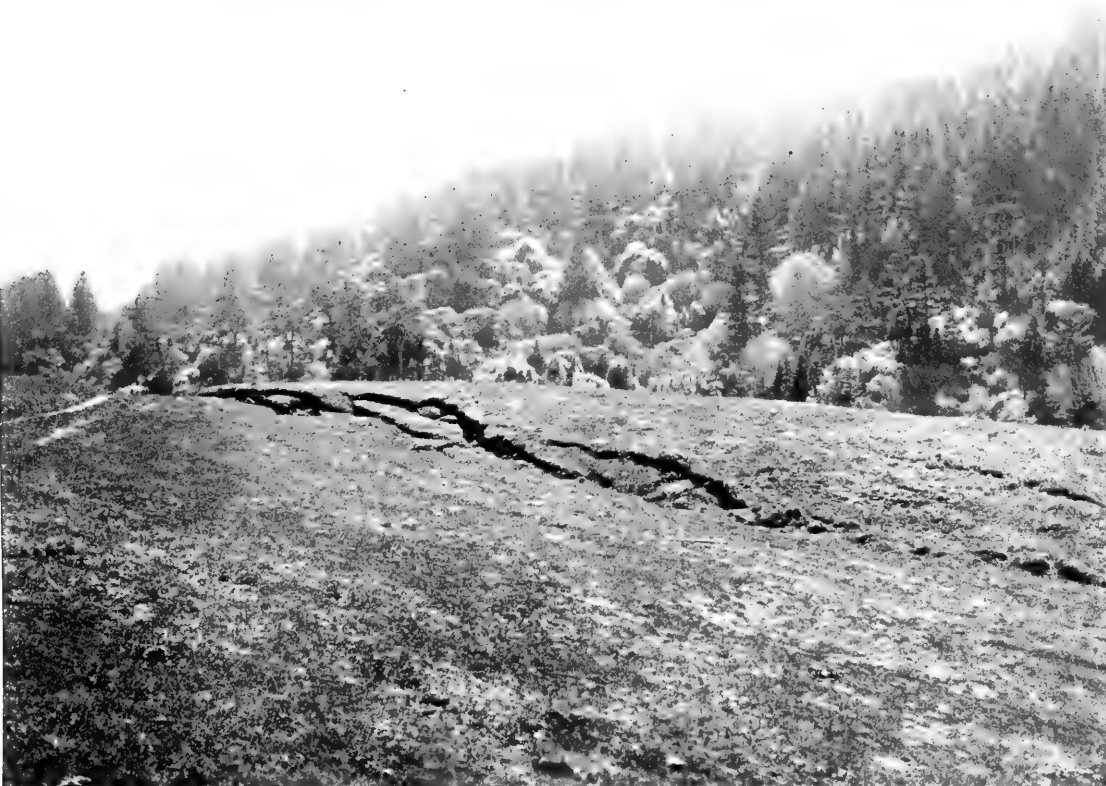
B. Branch of fault-trace, near Bondietti's ranch. Looking south. Illustrates diagonal cracks. G. K. G.

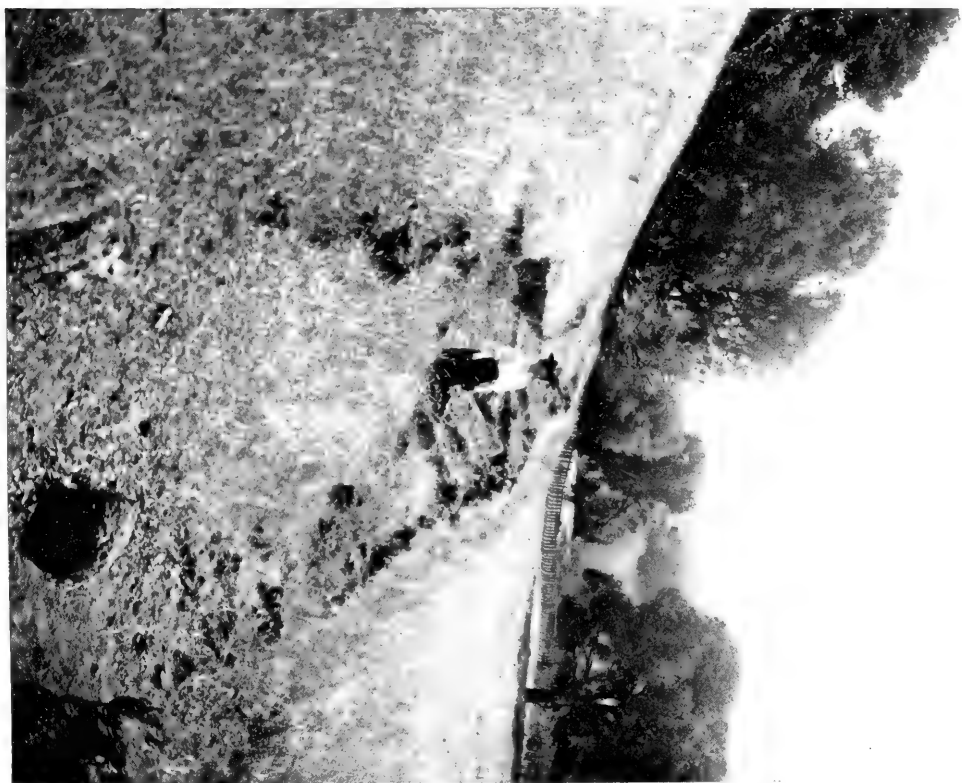
B. The fault-trace west of Olema. Looking southeast. Illustrates the trench phase. G. K. G.

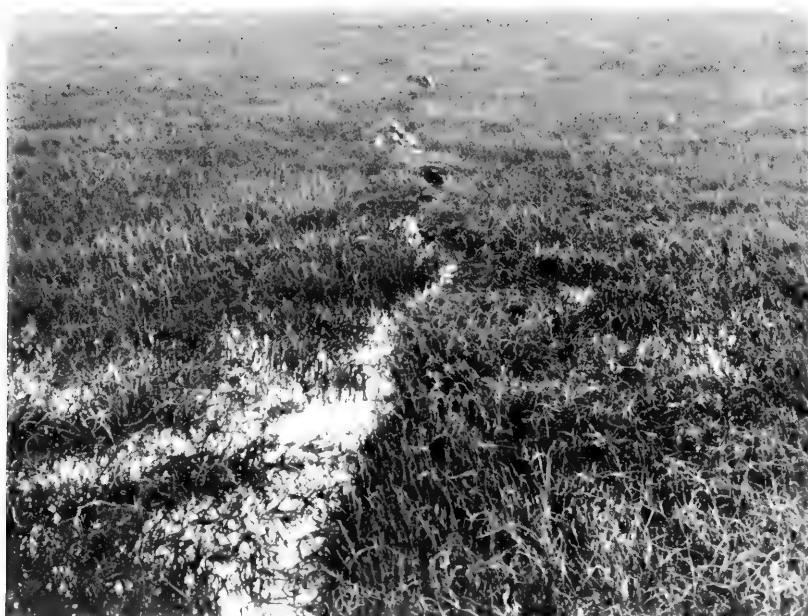
A. Looking southeast on Pepper Island. In the foreground the fault-trace is central. It trends toward the distant +. G. K. G.

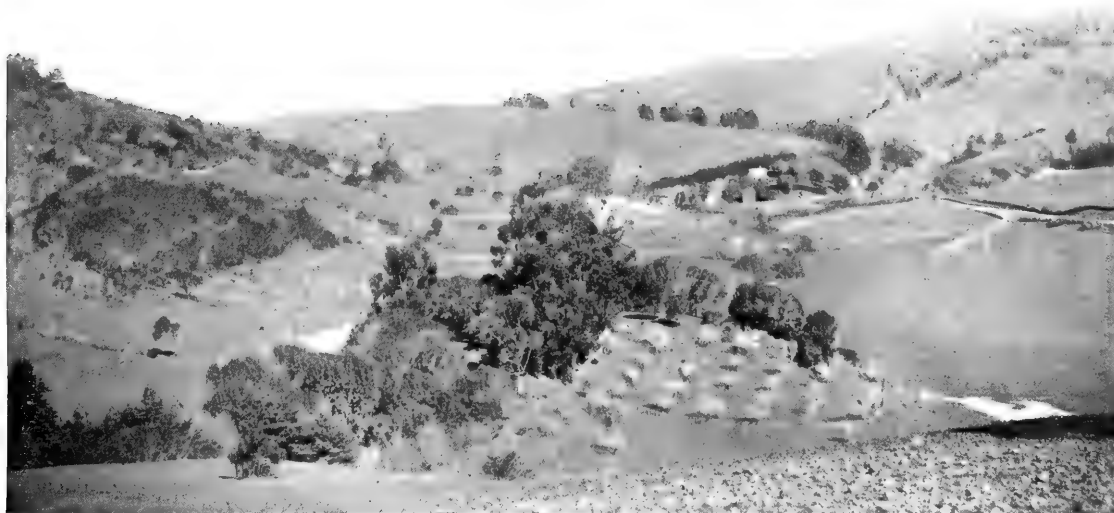
B. Looking north from hill west of Woodville. From buildings (Strain ranch) a large rift ridge runs northwest between 2 fault-sags. The western sag is followed by Pine Gulch Creek. Fault-trace runs from right of pond in foreground to left of buildings and follows sag for a mile, gradually crossing it. G. K. G.

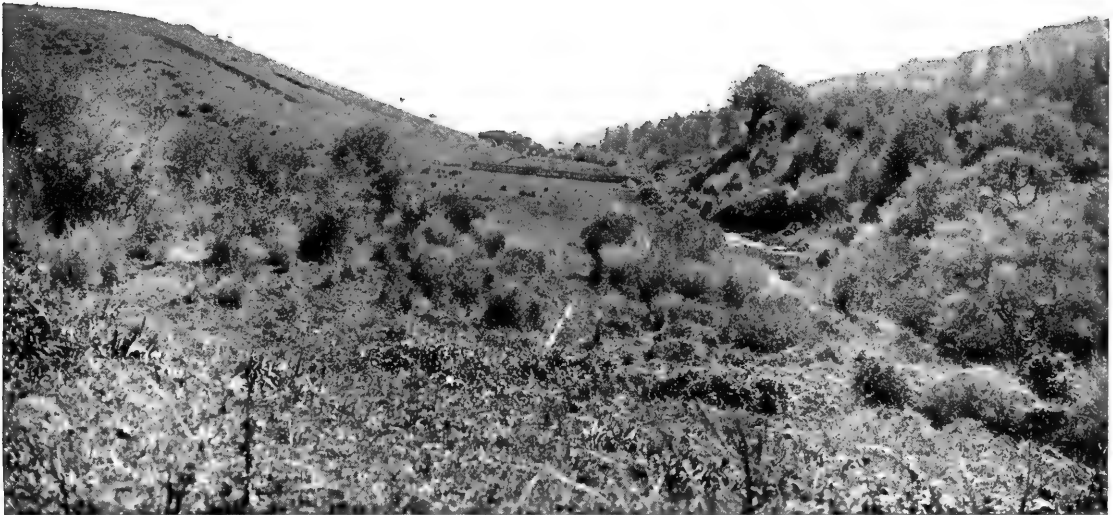
A. Sag followed by fault-trace a mile north of Strain ranch. Looking southeast. Trace, concealed by bushes, runs near ponds. G. K. G.

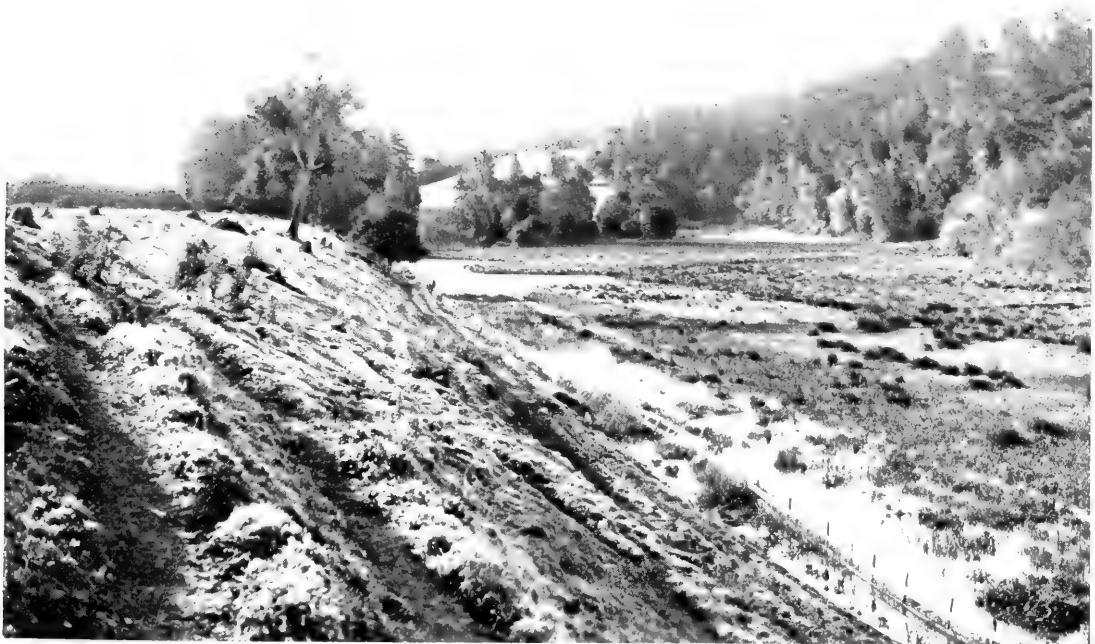
A mile south of the village of Olema the trace enters a sag which is followed continuously for nearly 3 miles. At first the sag is narrow and is attached to the northeast slope of a ridge, but approaching the Shafter place the ridge crest sinks and a broad sag replaces it in the line of trend. (Plate 42B.) In following the eastern edge of this sag from the Shafter place to Papermill Creek the fault-trace also follows the western base of a line of hills. The hills are peculiar in that their western, or more strictly southwestern, base, being determined by faulting, is nearly straight (plate 42B); while their northeastern base, modified by the erosive action of Olema Creek, is scalloped. In this region the ridge phase of the fault-trace dominates, being occasionally replaced by the trench phase. (See

B. Looking southeast from point near Shafter's ranch, Olema. Fault-trace follows base of hill and includes water-filled depression. G. K. G.

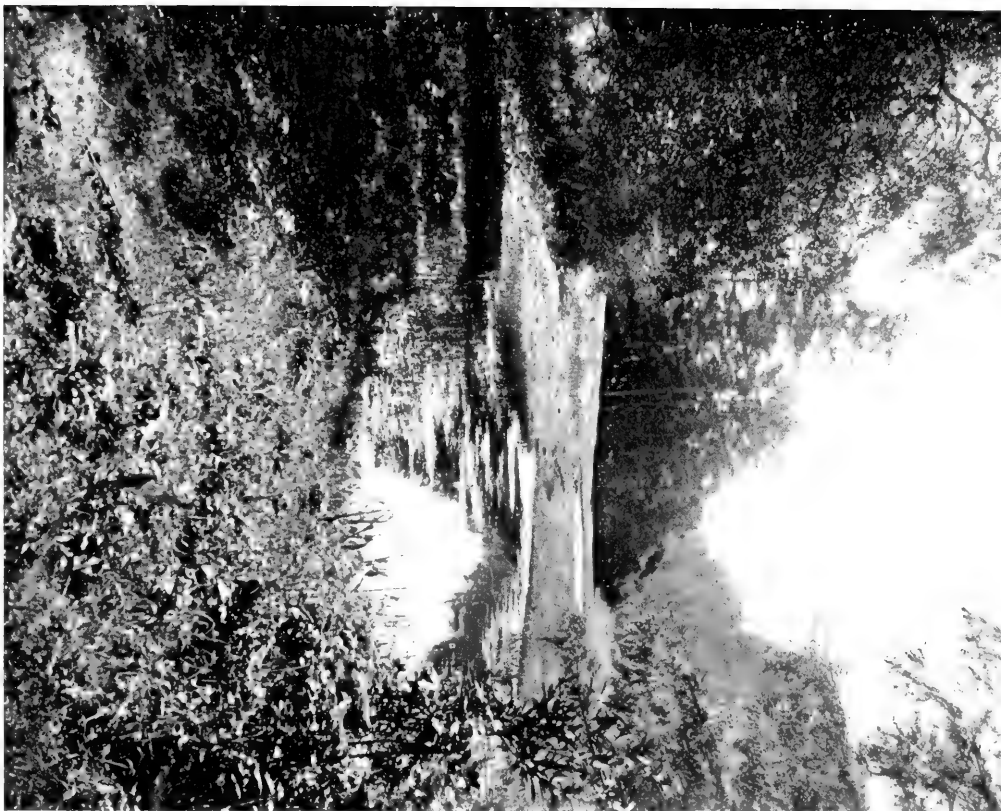
A. Fault-trace 1.5 miles south of Olema. Looking southeast. Trace touches both ponds, being best seen between them. G. K. G.

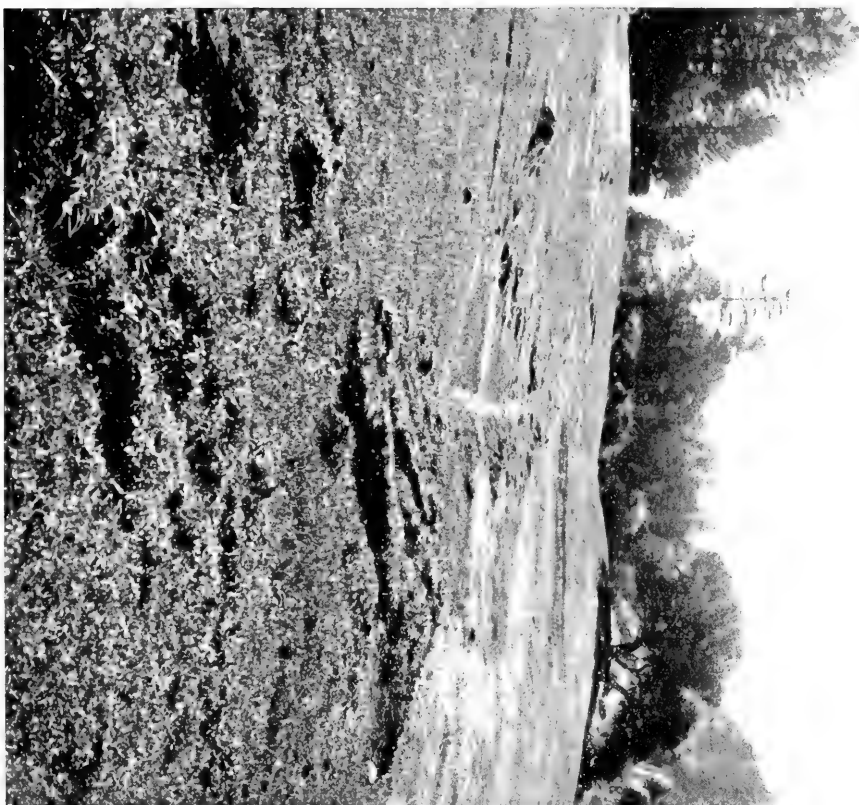
B. Looking southeast across hill-top a mile south of Olema. Shallow sag gives hill double crest and makes a pond basin. The fault-trace, both in foreground and beyond, is divided in several branches. G. K. G.

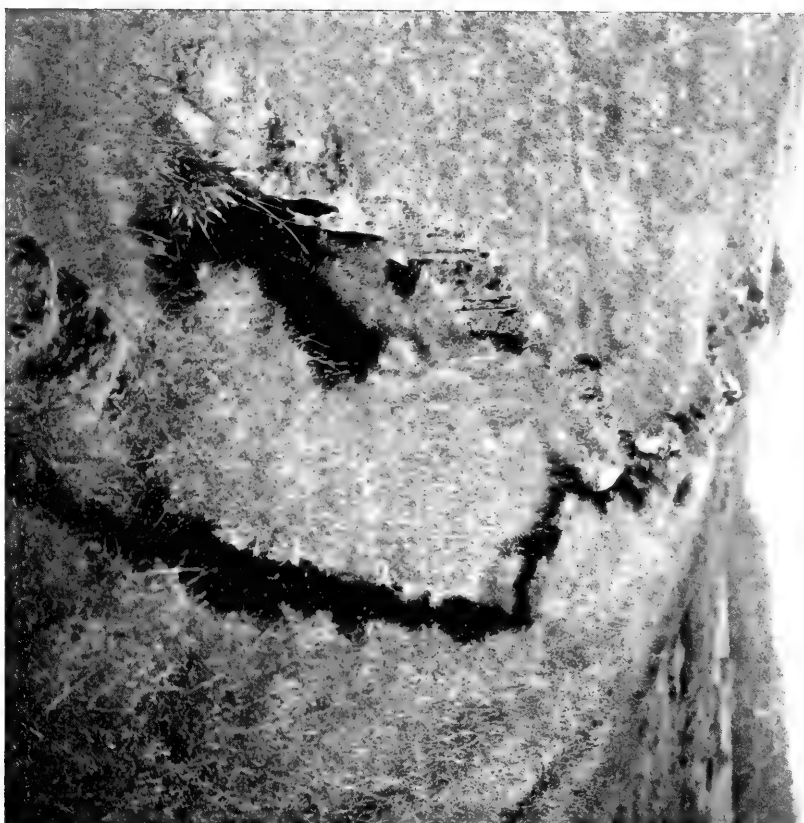
B. Fault-trace a mile northwest of Olema. Looking southeast. G. K. G.

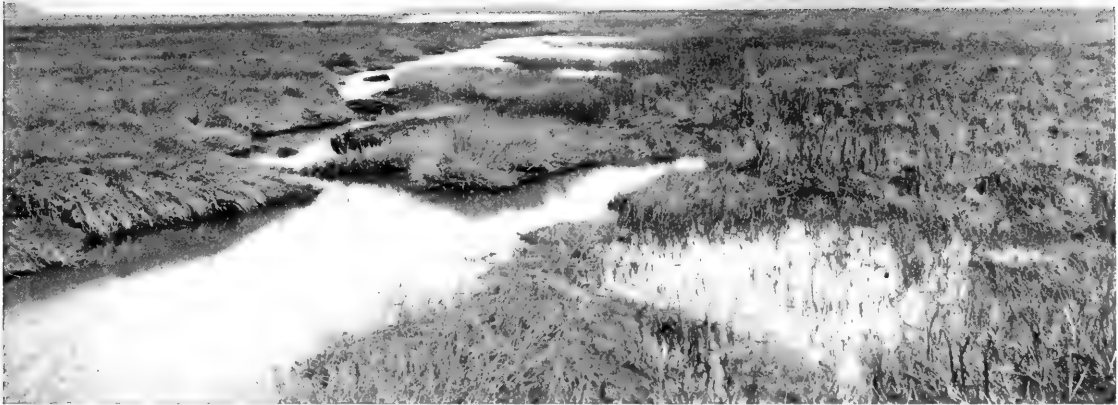
A. Fault-trace on Papermill delta. Looking northwest. The water lanes are largely at right of main line of fracture. G. K. G.

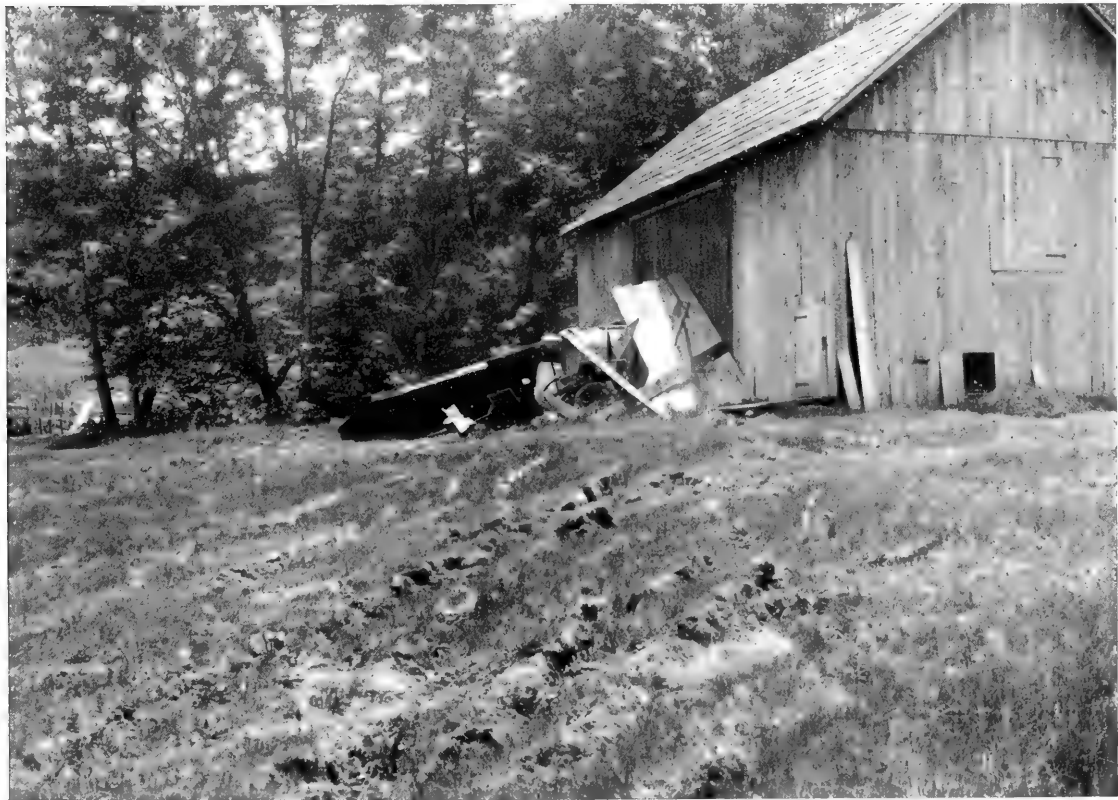
B. Branch of fault-trace in "Second Valley," at Inverness. Looking south-southeast. G. K. G.

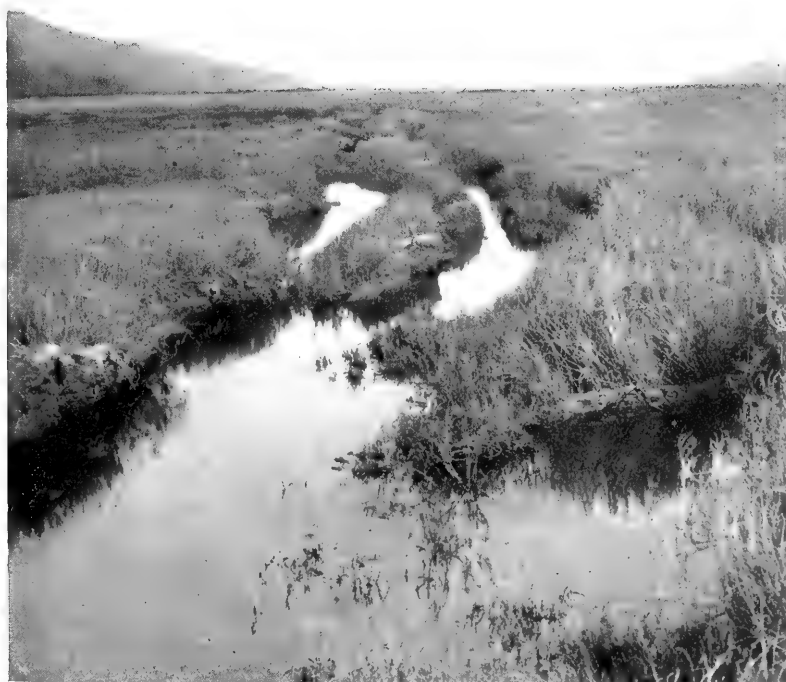
A. Fault-trace on Papermill delta. Looking northwest. G. K. G.

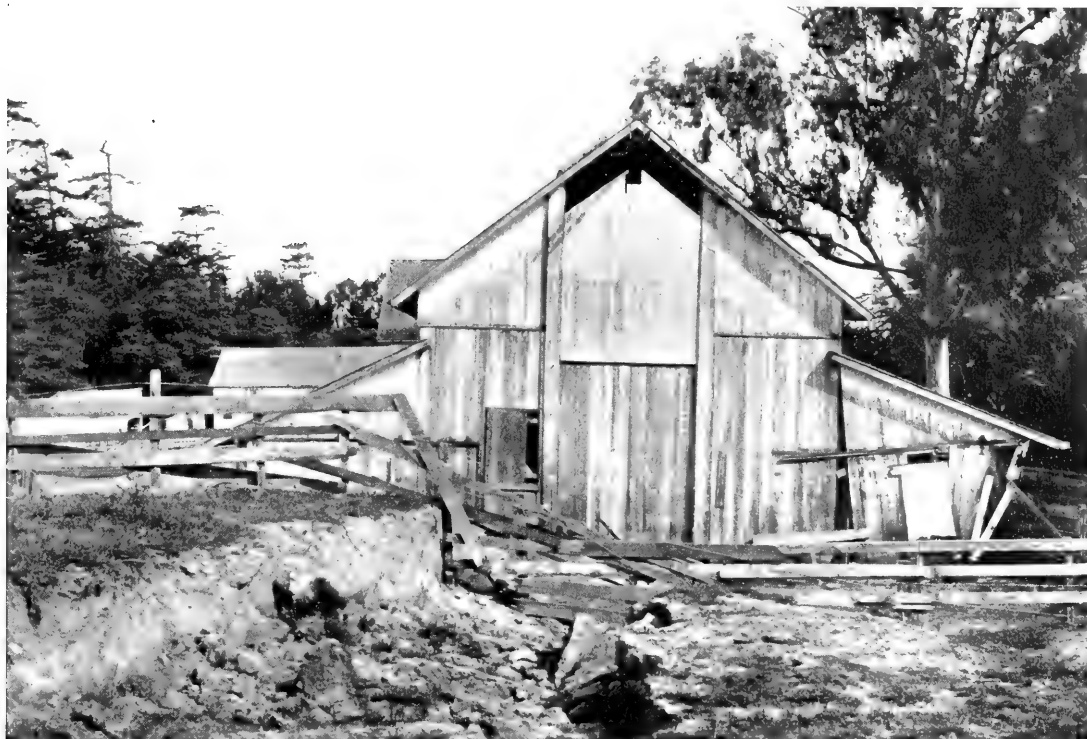
B. Fault-trace at the Skinner place, near Olema. Illustrating trench phase. G. K. G.

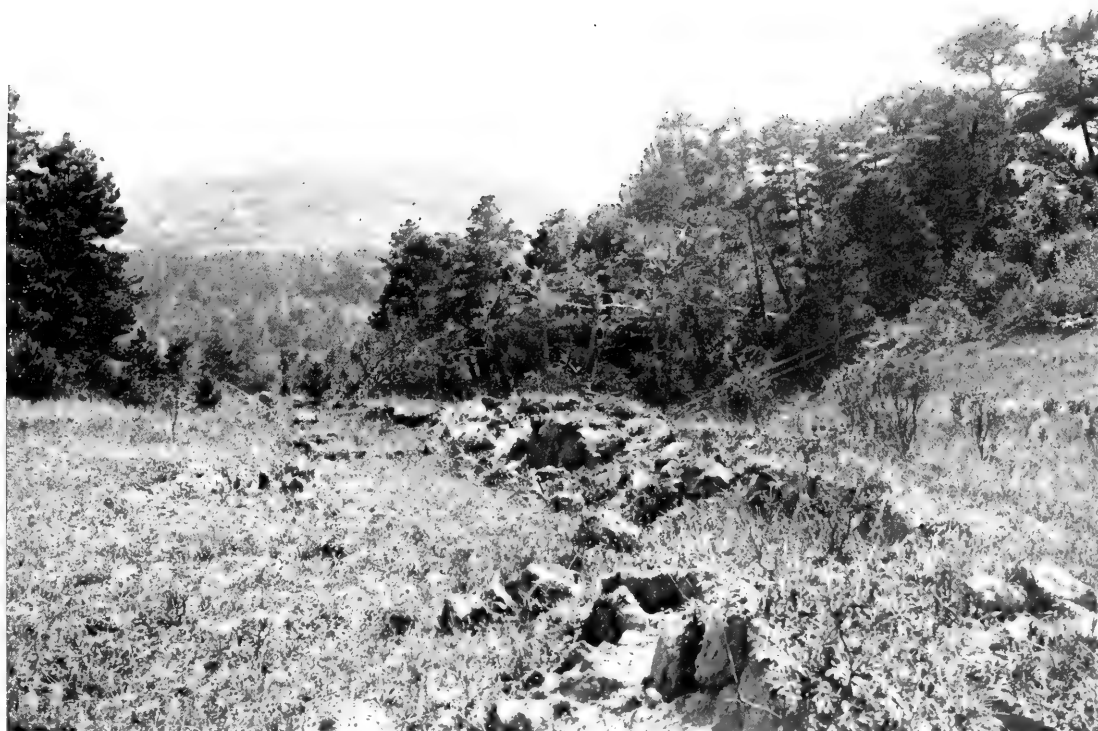
A. Branch of fault-trace on "north mesa" at Inverness. Looking southeast. G. K. G.

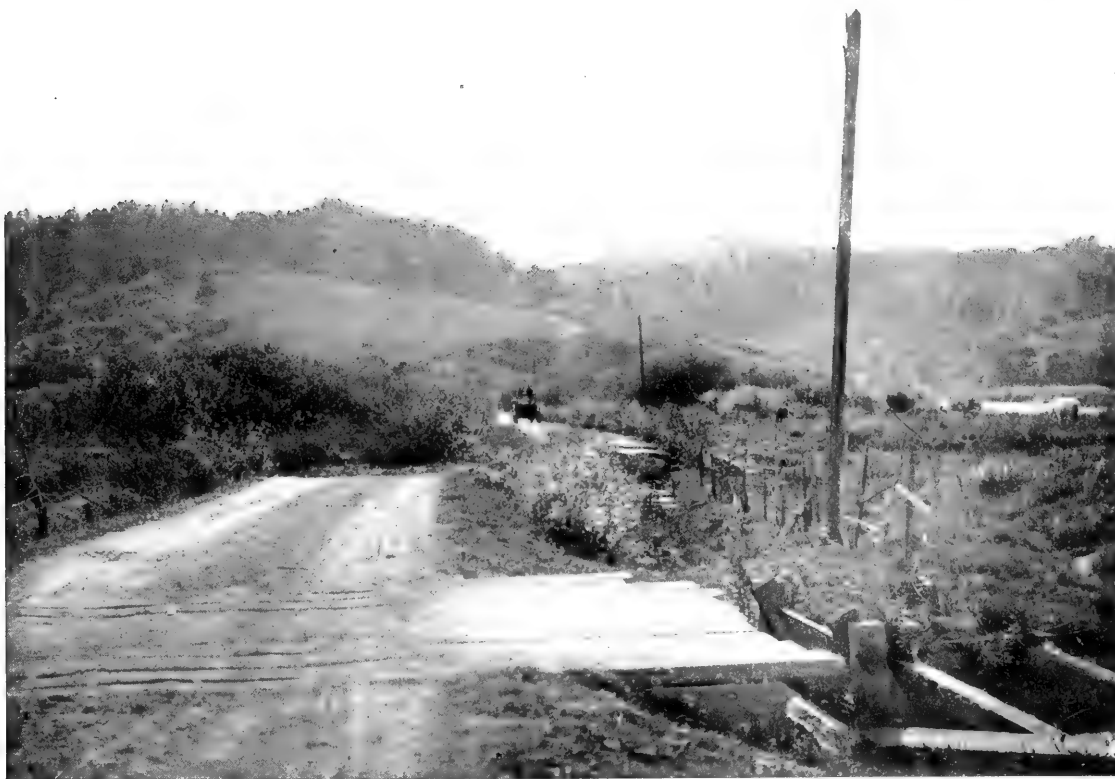
B. Road offset by fault. Looking southwest. G. K. G.

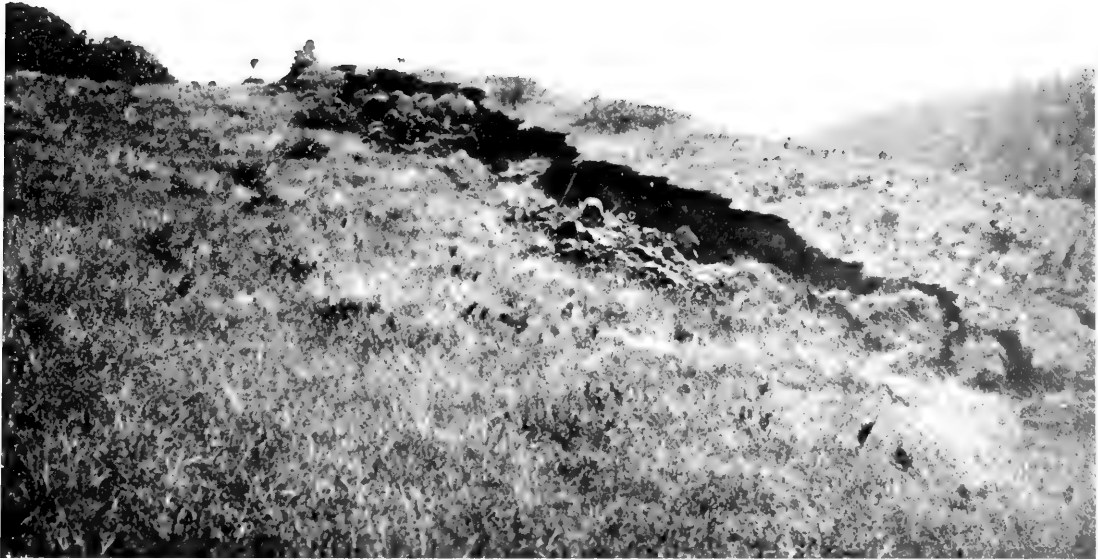
A. Fault-trace a mile northwest of Olema. Looking south. Appearance of vertical displacement largely due to combination of horizontal displacement with slope of ground. G. K. G.
